Assessment of Environmental and Economic Benefits Associated with Streambank Stabilization and Phosphorus Retention

by Lisa C. Hubbard, David S. Biedenharn, and Steven L. Ashby

ERDC WQTN-AM-14 May 2003

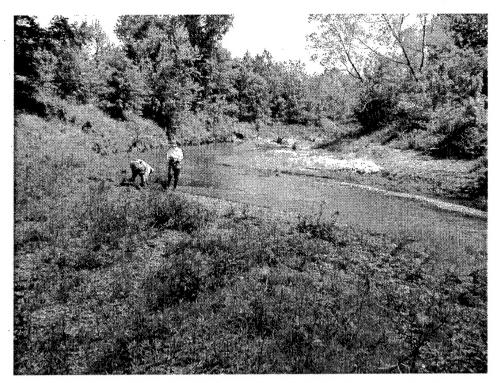
Geomorphic Status of Harland Creek Post Stabilization. After nine years, the bendway weir and longitudinal peaked stone toe sites viewed during the field investigation seemed to be performing adequately with minimal bank erosion. Figure 3 shows an example of the stable banks with vegetation successfully colonizing and maturing. There are a few sites where raw banks were visible directly next to bendway weirs, as seen in Figure 4. However the majority of the raw banks appear to coincide with the willow post sites, an example of which is seen in Figure 5. The raw banks at the willow post sites may be due in part to the low survival rates of the willow posts. According to Pokrefke et al. (1996), survival at the willow post sites was at 80 percent in spring of 1994 but dropped to 42 percent by October. By 2002 there is almost 100-percent mortality of the willow posts. Although some of the banks are raw, they have not retreated much as remnants of the willow posts are still visible. Field observation at these sites revealed that there has been erosion at the toe (1 to 2 ft). This is supported by a numerical model study conducted in 1999 that found the added roughness of the willow posts increases stress on the toe (Watson et al. 2001). While it is possible that the willow post remnants may be contributing to the stability of the banks, it is more likely that the historical erosion rates in these bends were lower due to the presence of resistant bank material and the longer radius of curvature bends.

Figure 3. Reach 11, bendway weir site

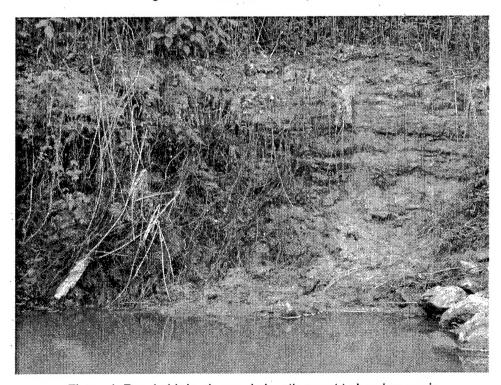
Figure 4. Reach 11, bank sample location next to bendway weir

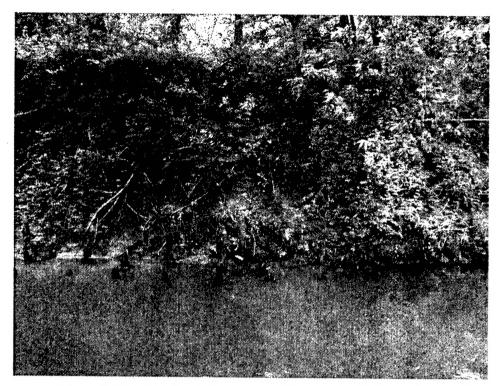
Figure 5. Reaches 6 and 7, willow post site, bank sample location
